Hawes Associates

Shotley Stour footpath renovation. Conceptual design report.

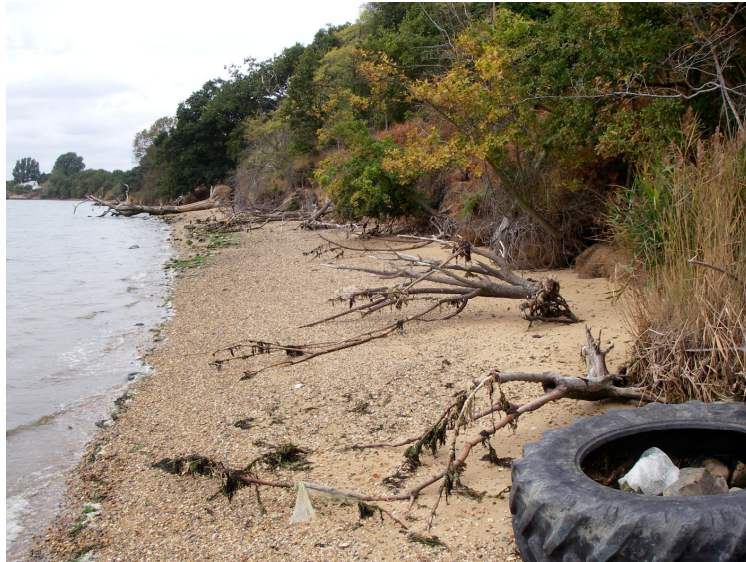
Zone 3 beach 23/9/09

Erosion along this length has washed away all traces of the coastal path that ran here. A near vertical 2m high exposure of London Clay covered by the Pliocene Crags can be seen on the shore here. Continued undermining and over toppling of soils from higher up the cliff leaves this section very vulnerable to high winds from the south west generating significant wave amplitudes.
